RTD LABORATORY REPORT

Project Name:	Casper Alcova Irrigation District
Project Location:	Casper, WY
Construction Date:	Completed January 1991
Area of Membrane Installation:	Approximately 2,000,000 square feet

Type:		
Irrigation Canal

Three Teranap 431 geomembrane samples from the above referenced project were received by the RTD laboratory on February 5, 2011. The samples were submitted to evaluate the product's performance after 20 years in-place.

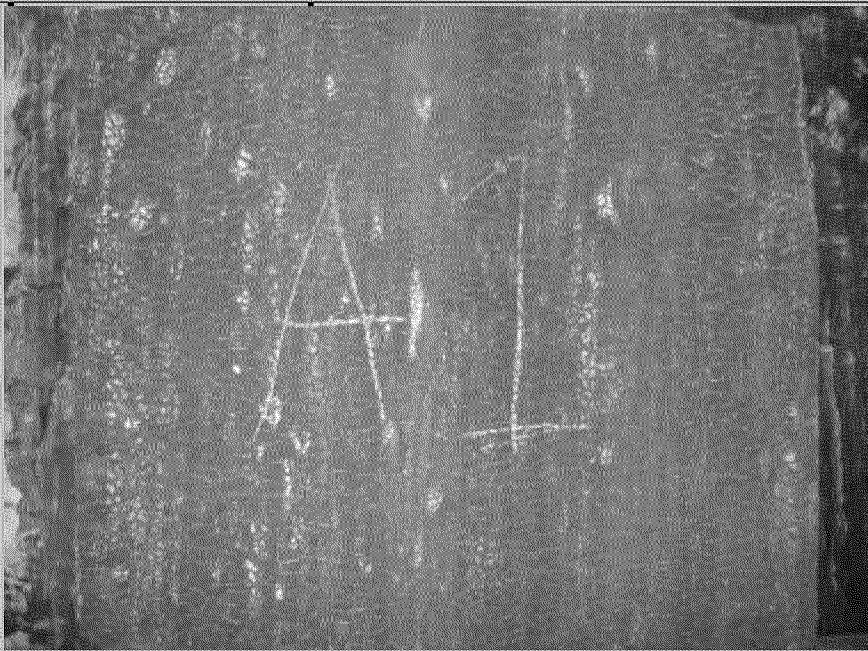
Sample Description: Sample Size and Surface Appearance		
Sample #A1	Size: 590 in ² (4.1 ft ²)	Comments: Crazing was observed on the surface of the Teranap.

1. Samples A1 and A2 were taken from the upper wall of the irrigation canal where the membrane was directly exposed to UV light and the elements. These samples exhibited alligatoring on the surface. Microscope imagery indicated that the depth of the crazed SBS bitumen waterproofing did not penetrate to level of the reinforcement within the cross-section of the Teranap.

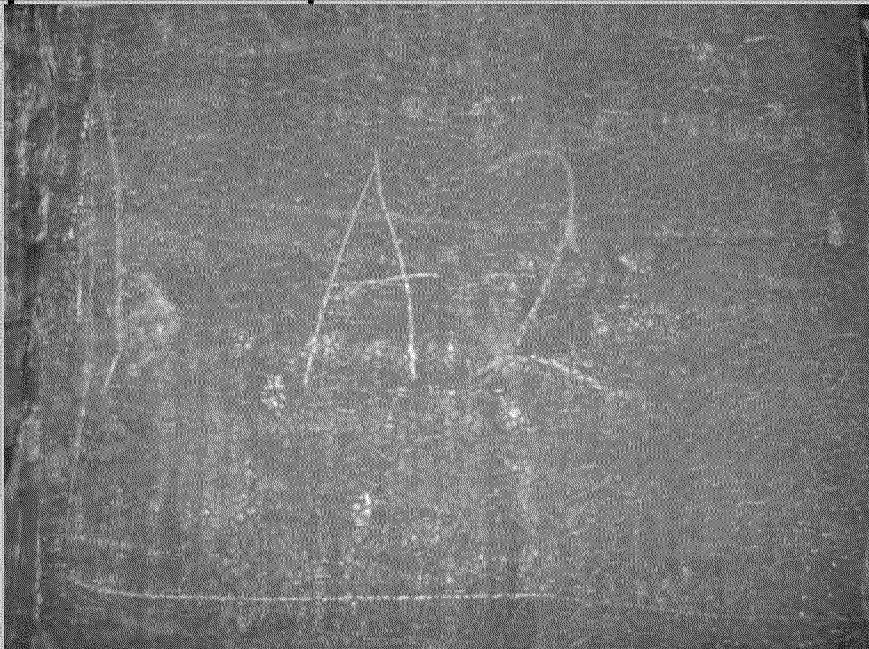
Sample Description: Sample Size and Surface Appearance		
Sample #A2	Size: 675 in ² (4.7 ft ²)	Comments: <u>Crazing</u> was observed on the surface of the Teranap.

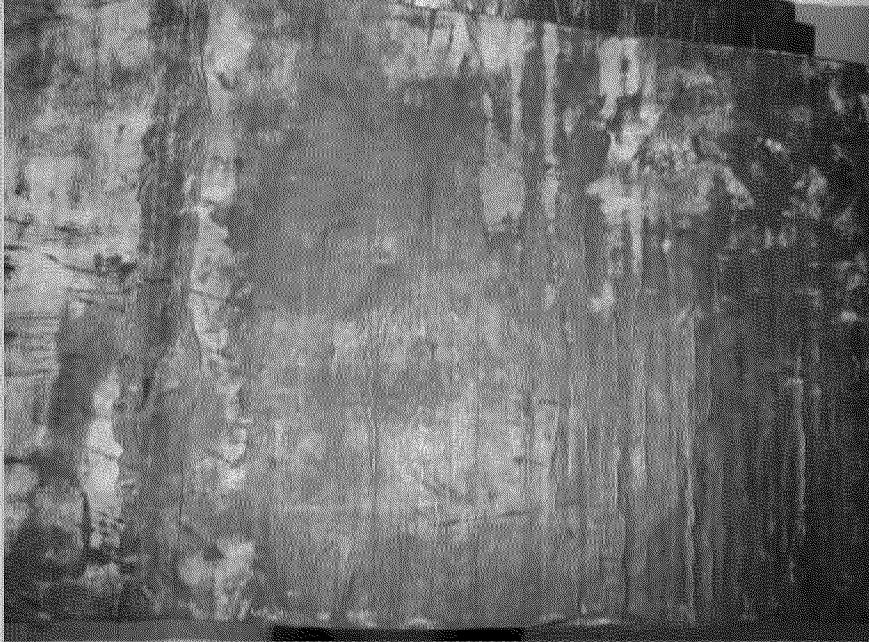
Sample #B1	Size: 1279 in ² (8.9 ft ²)	Comments: No obvious signs of product or application issues were visible on the surface of the sample.

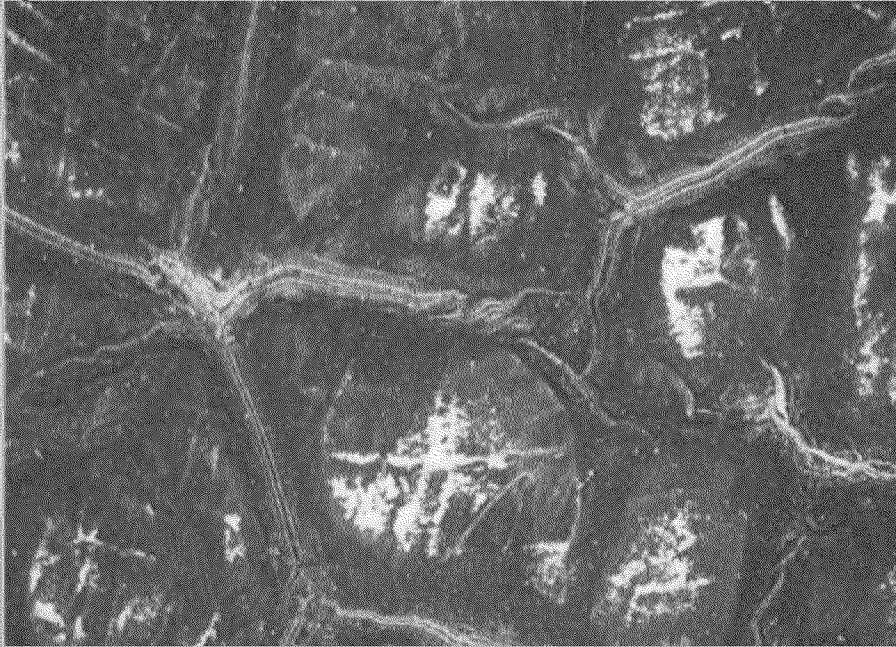
**Sample
#A1**

The microscope image indicates alligating in the surface of the Teranap.

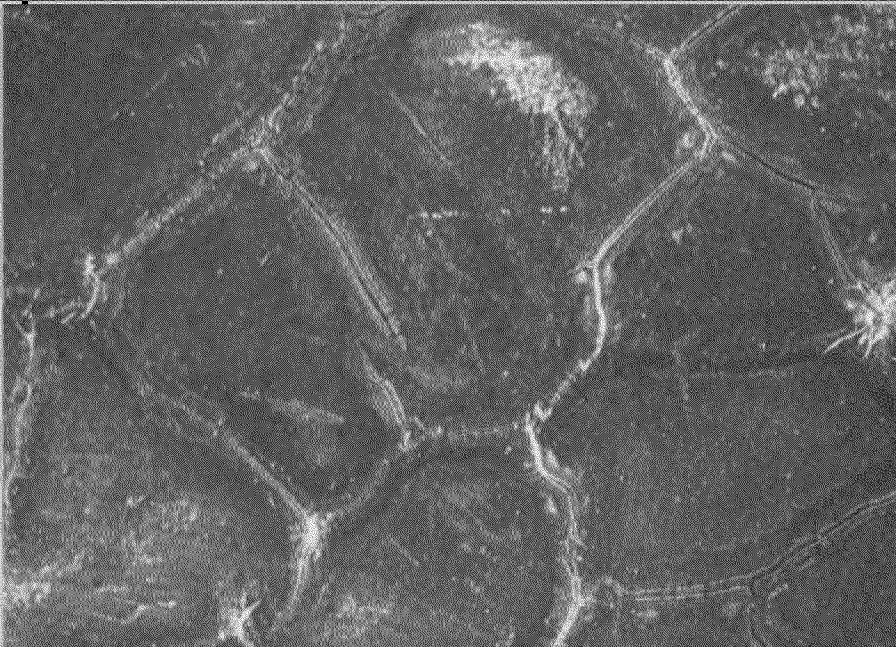
**Sample
#A2**

The microscope image indicates alligating in the surface of the Teranap.

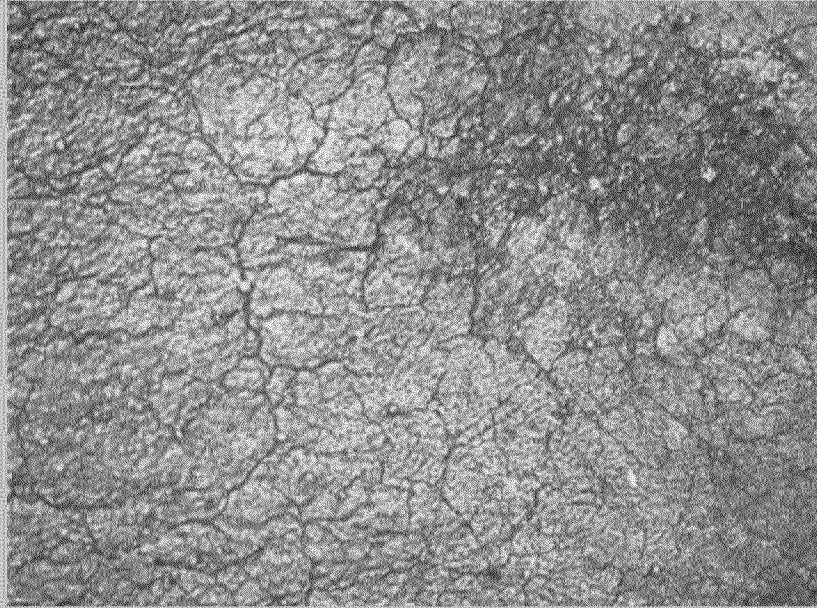
Sample #
B1

The microscope image indicates checking (minor crazing) on the surface of the Teranap.

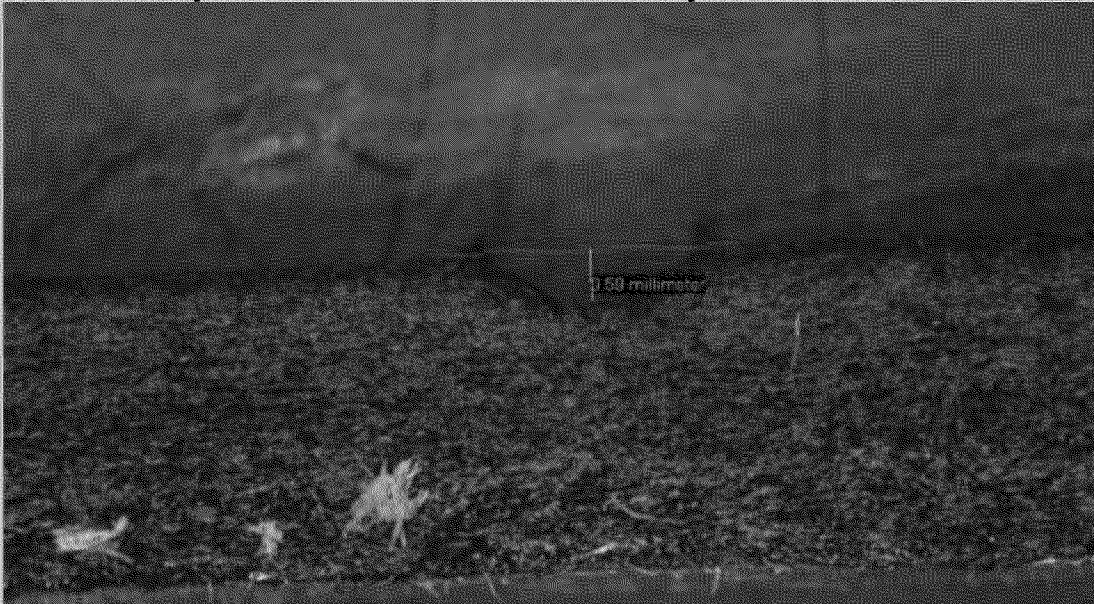
Sample #A1

Average Channel Depth
23 mils (0.58 mm)

Reinforcement Depth
40 mils (1.02 mm)

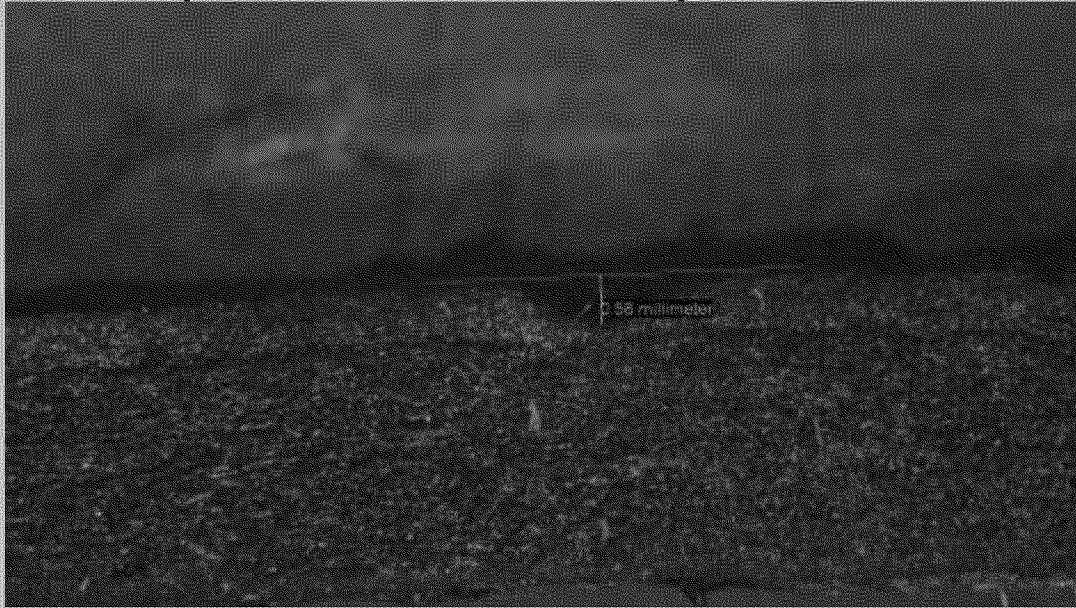
Sample #A2	Average Channel Depth 21 mils (0.54 mm)	Reinforcement Depth 28 mils (0.70 mm)

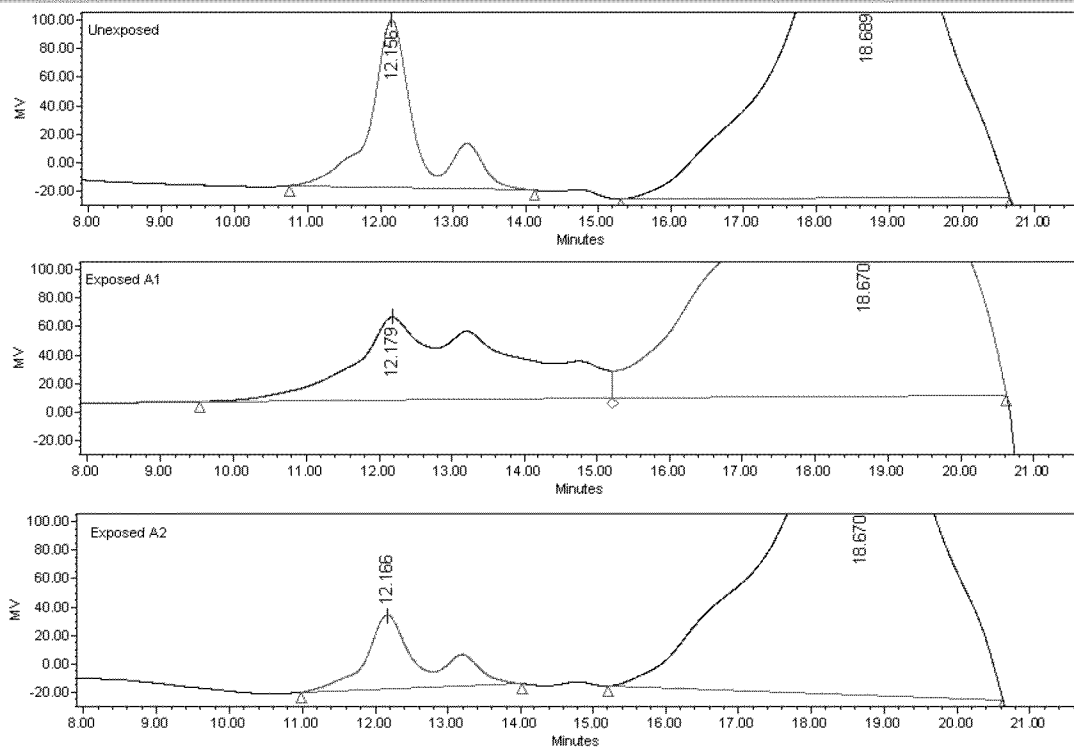
Comments: The image compares the GPC curves for the individual samples. Based on the results there appears to be some polymer degradation in the exposed samples.

5. GPC (gel permeation chromatography) analysis was performed on the SBS bitumen, and the exposed samples experienced a higher rate of polymer degradation than B1, however active (intact) SBS polymer remained in both A1 and A2.

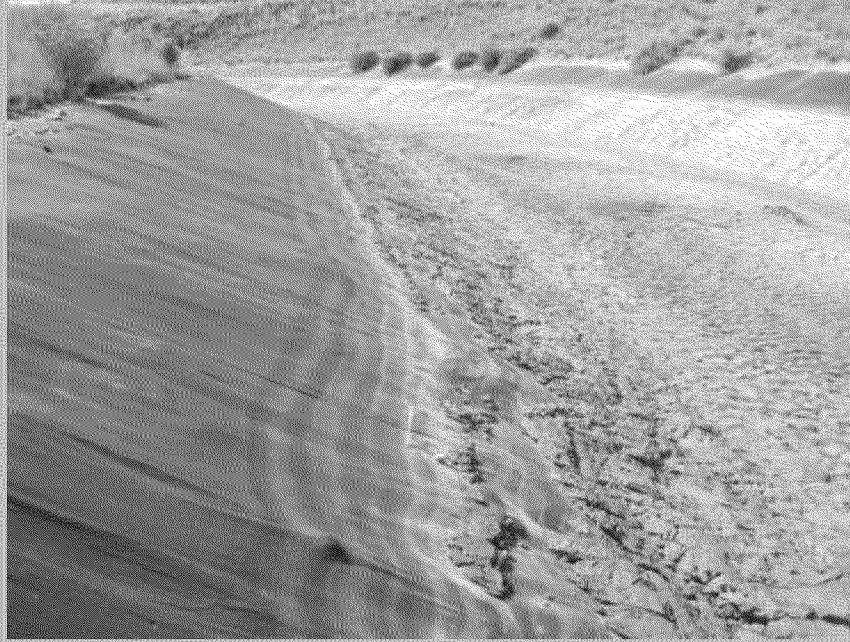
Comments: The image depicts the general condition of the irrigation canal. Note the exposed Teranap on the walls of the canal; this is the general area where Samples A1 and A2 were taken.

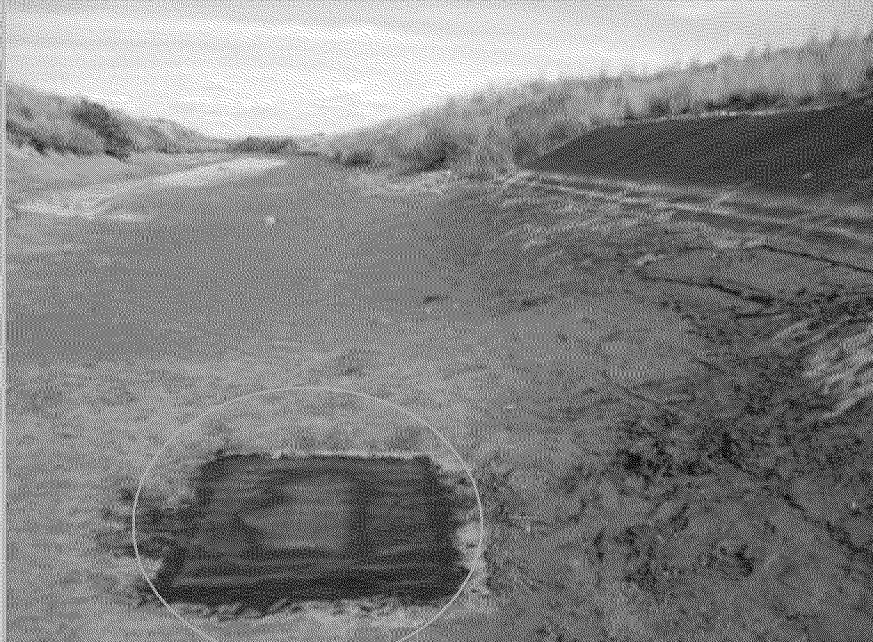
Comments: The image indicates where Sample B1 was extracted.

2. Sample B1 was extracted from beneath a layer of sediment in the bed of the canal. The sample had experienced limited, or no, direct exposure to UV. Due to the water and earth covering it is safe to say that this sample maintained a relatively constant and moderate temperature compared with the exposed samples A1 and A2.
